Conservation of the Tomb of Safi-ud-Din Garzoni at Uch Sharif, district Bahawalpur, Punjab, Pakistan

Figure 5: Front view of Tomb, Safi-ud-Din Garzoni at Uch Sharif

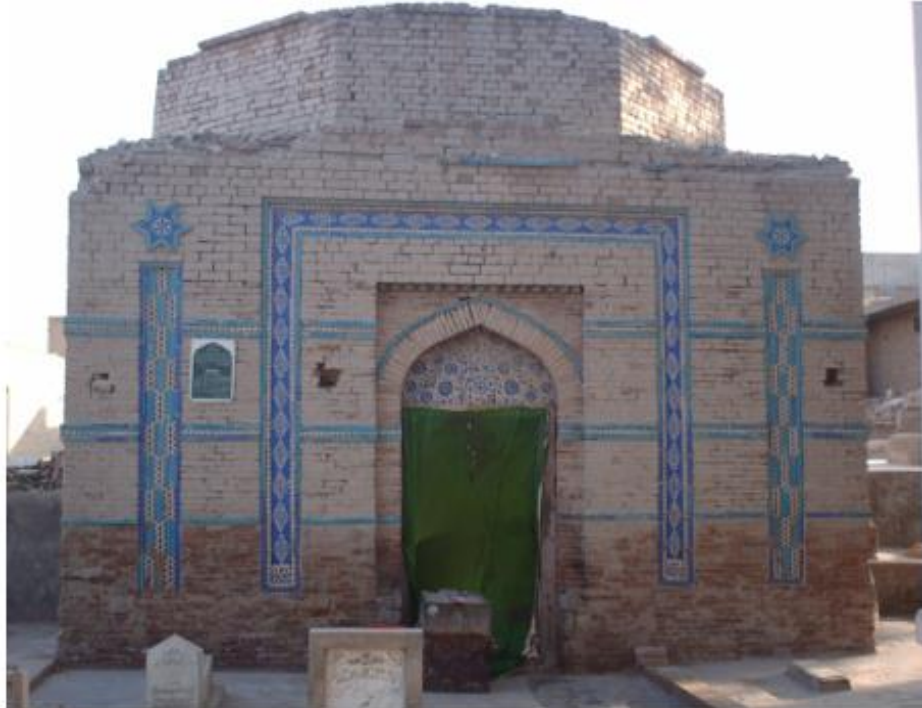
With the time glaze kasha tiles are decaying. The main roof/ceiling of the monument is demolished due to natural factors i.e., Rains, etc. Thorough conservation is required as per the original pattern.

The tomb's exterior is decorated with beautiful, glazed Kashi tiles. The tomb is constructed in a rectangular plan, which is built at an elevated level from the ground. As with time dilapidated structure has lost flat roof. The walls are decorated and ornamented with glazed tiles and Kashi Gola, Marlon. There are several graves inside the monument. Conservation/restoration work is necessary to preserve this monument.

other tombs, this one has openings on the south and east facades. The sirhana niche and mihrab would have most likely been located on the west and north facades, respectively.

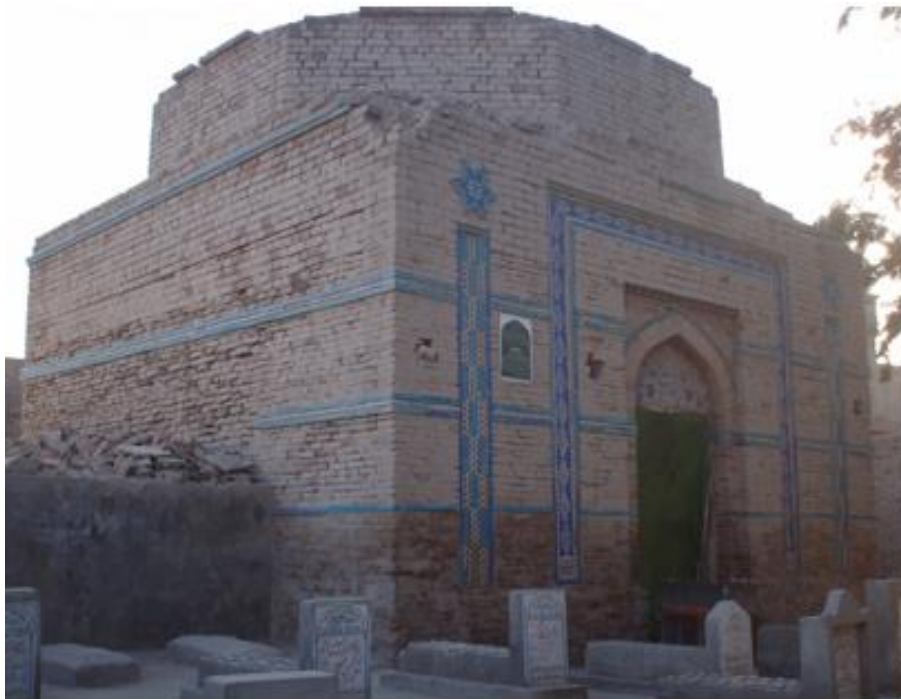
Figure 6: Side view of the Tomb, Safi-ud-Din Garzoni at Uch Sharif

The inner structural core of this monument is like that of other tombs in the city, while the revetment layers are mostly like those of Ustad Nuria. The physical properties of both have been discussed in the respective sections. Gypsum is used as the setting mortar for the flat tiles of the interior, while a layer of plaster with a ring of glazed tiles is used to cover the dome. Due to its inaccessibility, this plaster has not been examined. The authors suggest keeping in view its historical nature and distinct kind of construction, to keep the traditional building techniques to restore it (Ali *et al.*, 2020).
